Outfall, Basin & Streambank Inspection Report

Fremont Township

GHA Project # 4191.009

Summer 2011

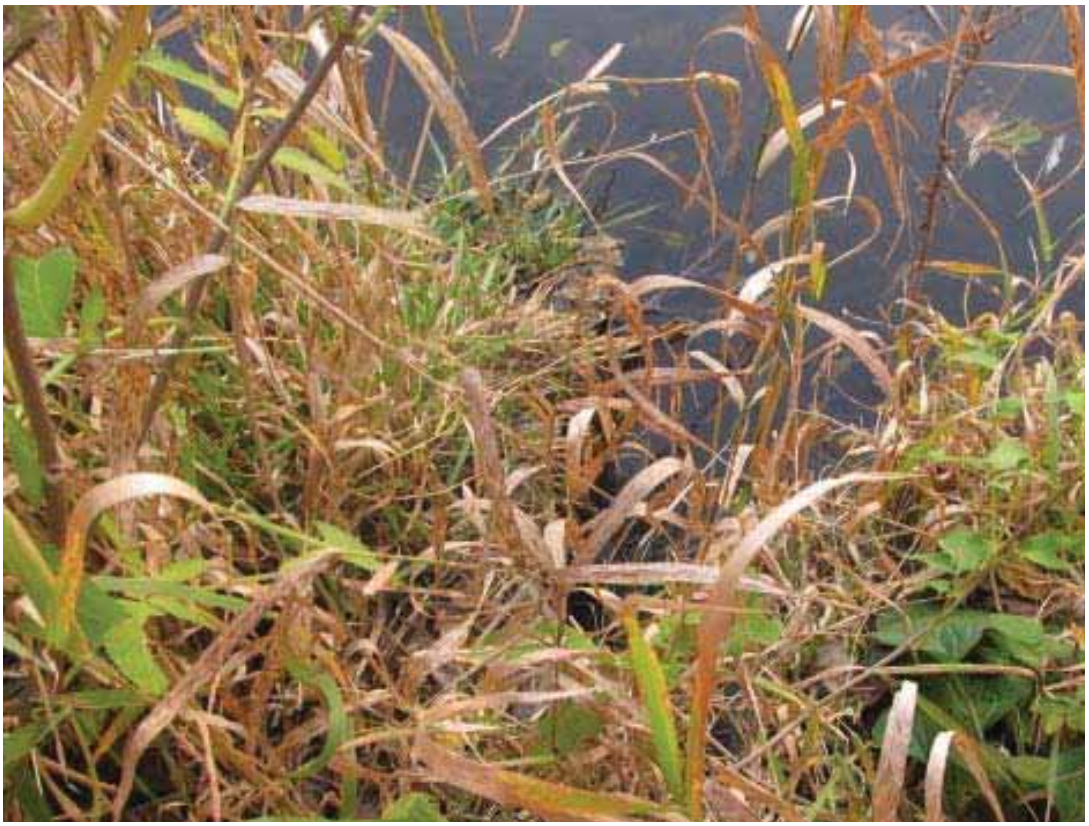
Dense vegetation surronding outfall, may be difficult to see.

Comment: Close-up of outfall partially submerged in water.

Comment: Representative view of the outfall.

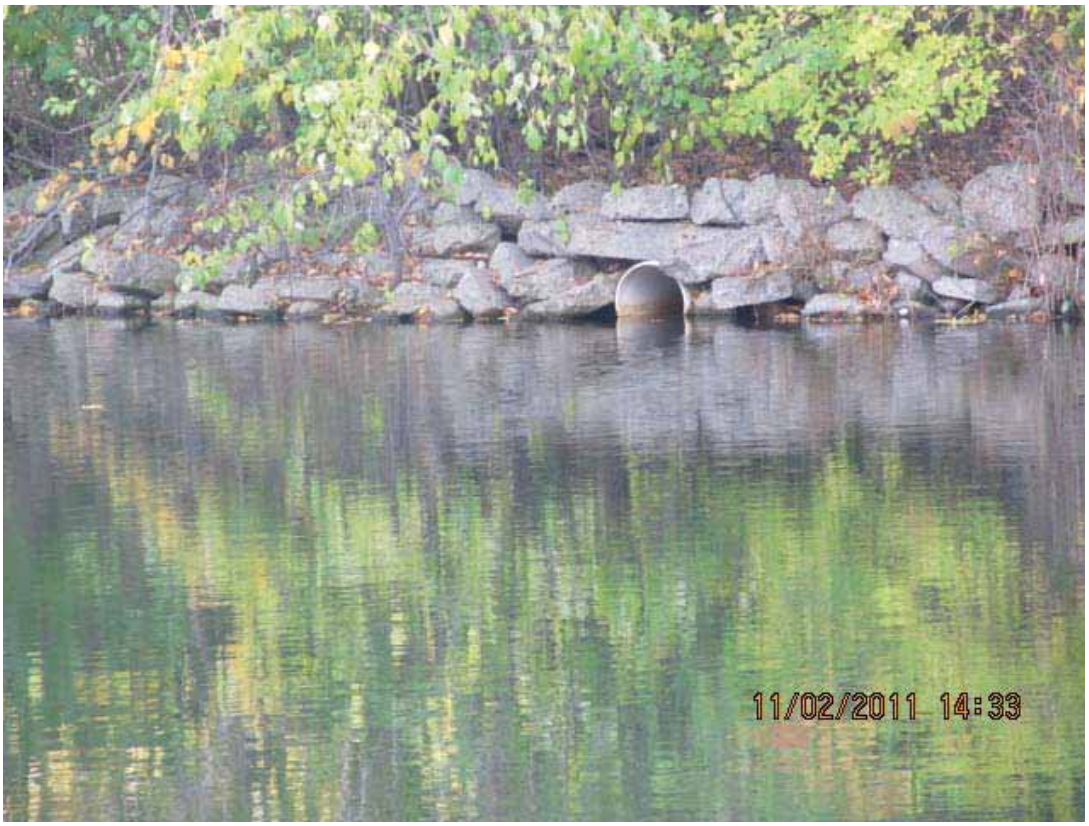
Comment: Close-up of the outfall.

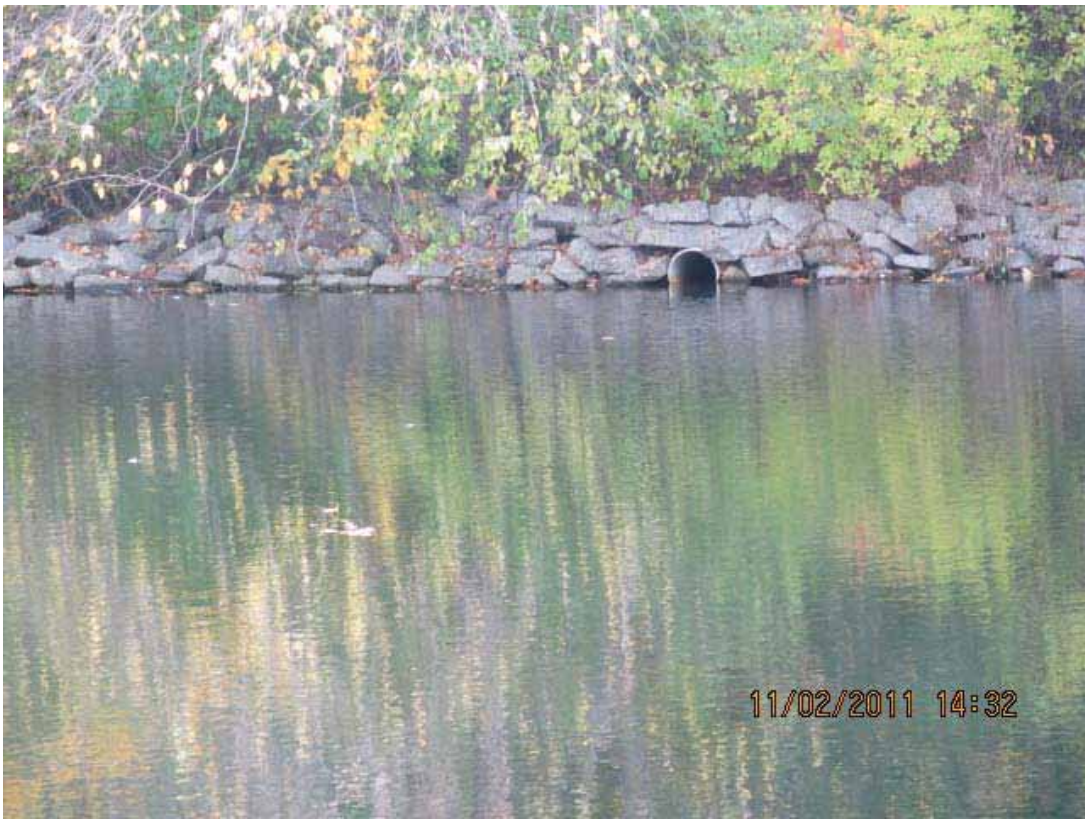
Comment: Representative view of the outfall.

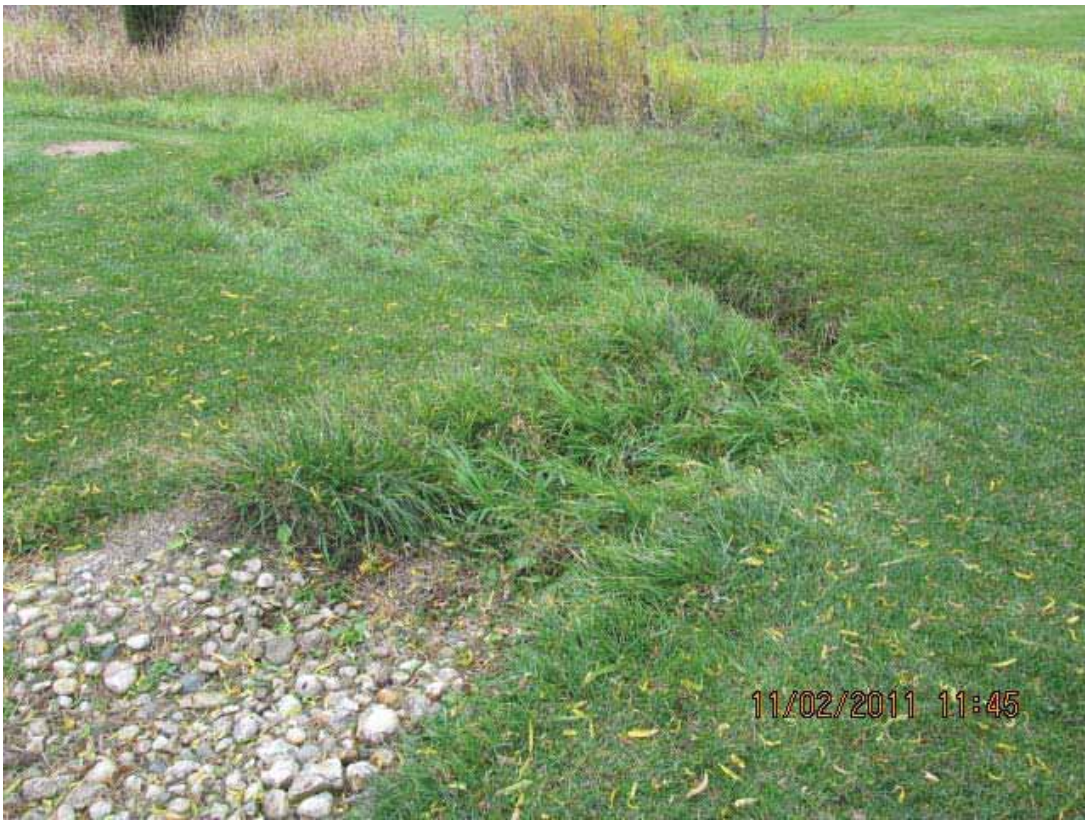
Comment: Creek is dry.

Comment: Representative view of the outfall.

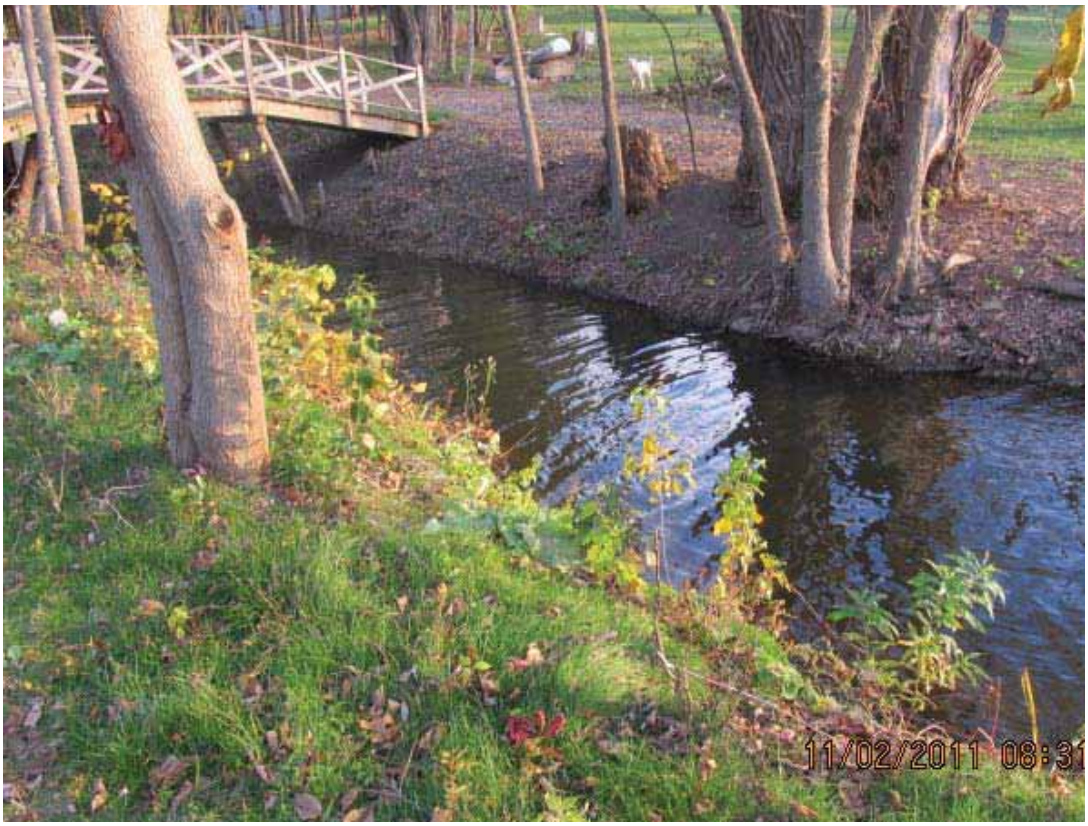
Comment: Close-up of the creek.

Comment: Representative view of the creek.

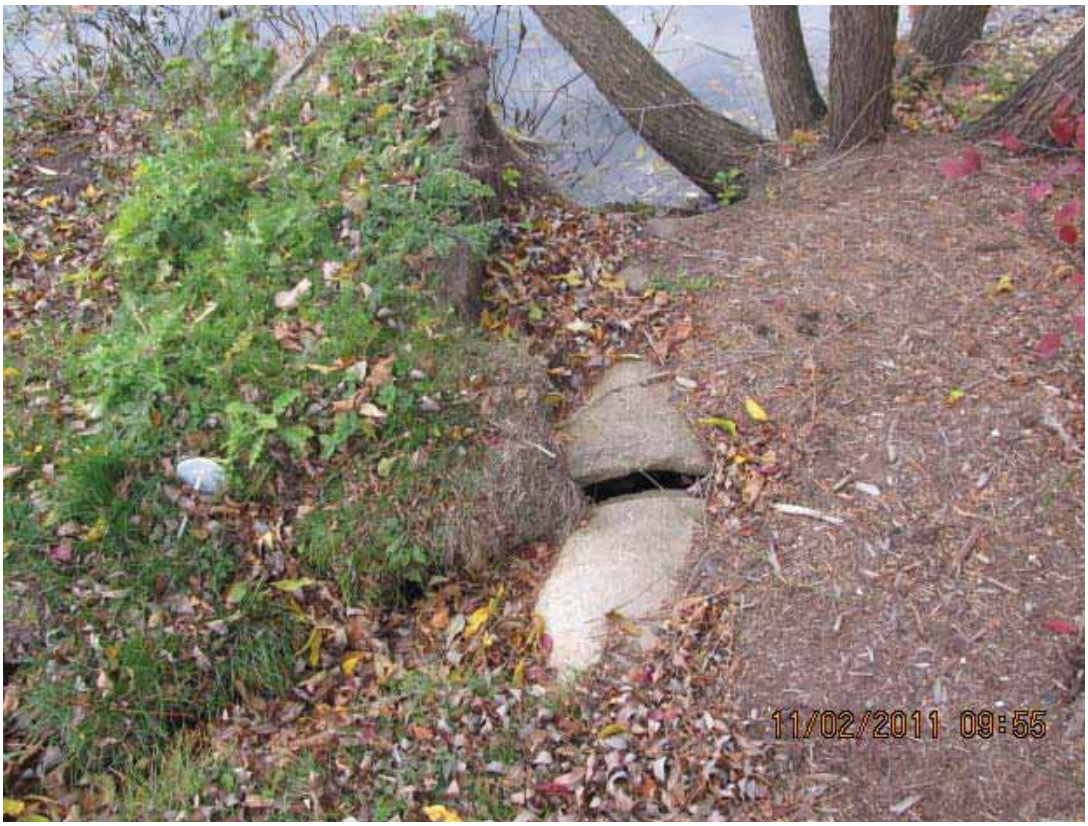
Flared end section is separating from storm pipe.

Comment: Close-up of the outfall partially filled with sediment and debris.

Comment: The flared end section is separating from its pipe.

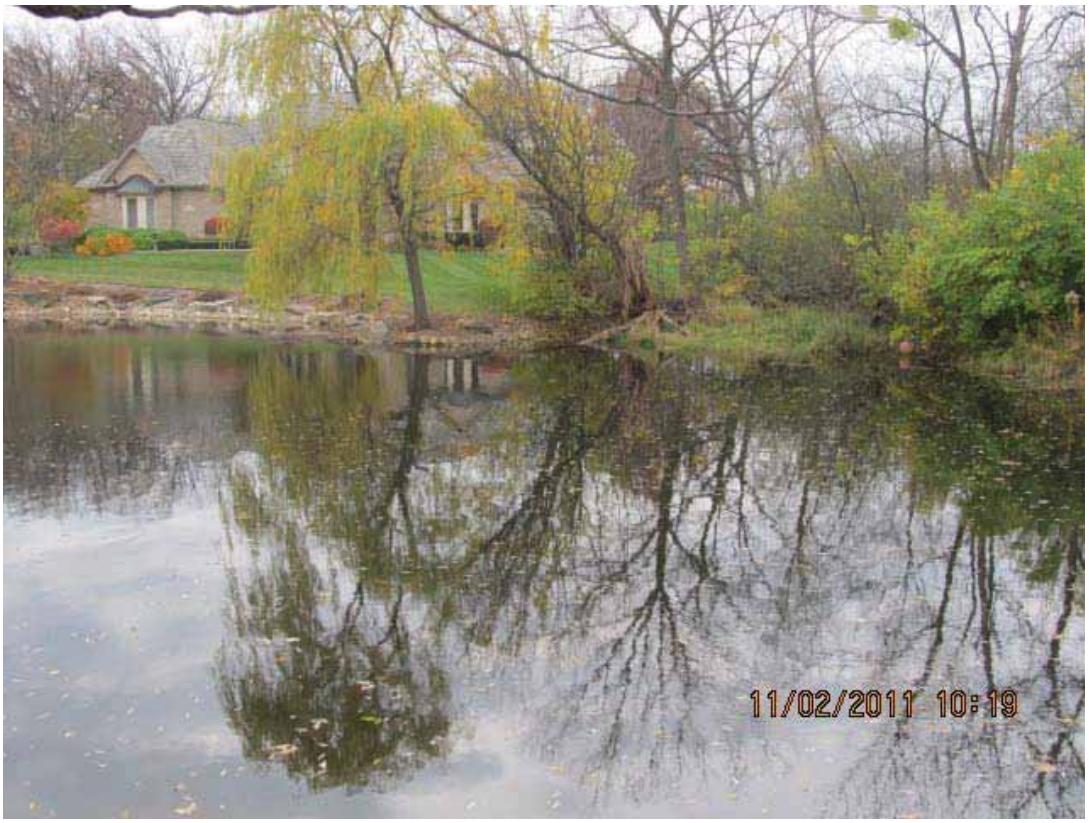
Comment: Close-up of creek.

Comment: Representative view of the creek.

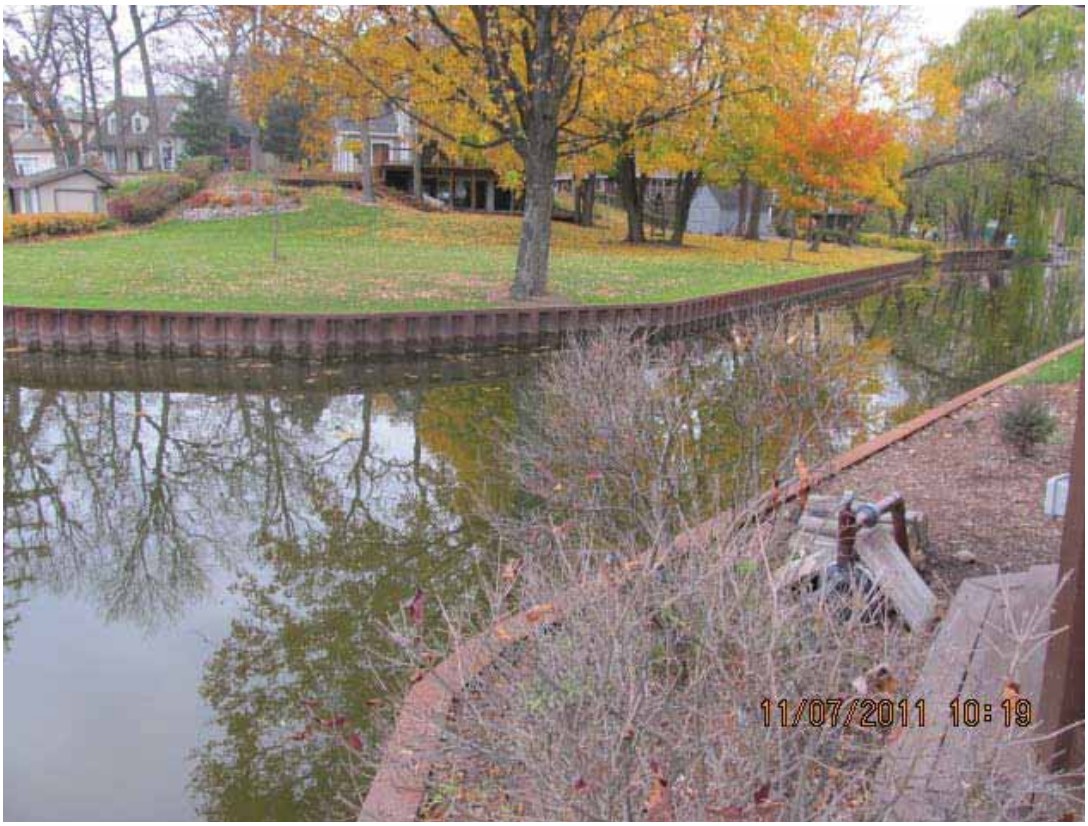
Comment: Close-up of the creek.

Comment: Representative view of the outfall.
